**Root Cause Analysis of  
TVA Kingston Dredge Pond Failure on  
December 22, 2008**

**Kingston Fossil Plant, Harriman, Tennessee**

**Project No. 60095742  
June 25, 2009**

**Volume I – RCA Report**

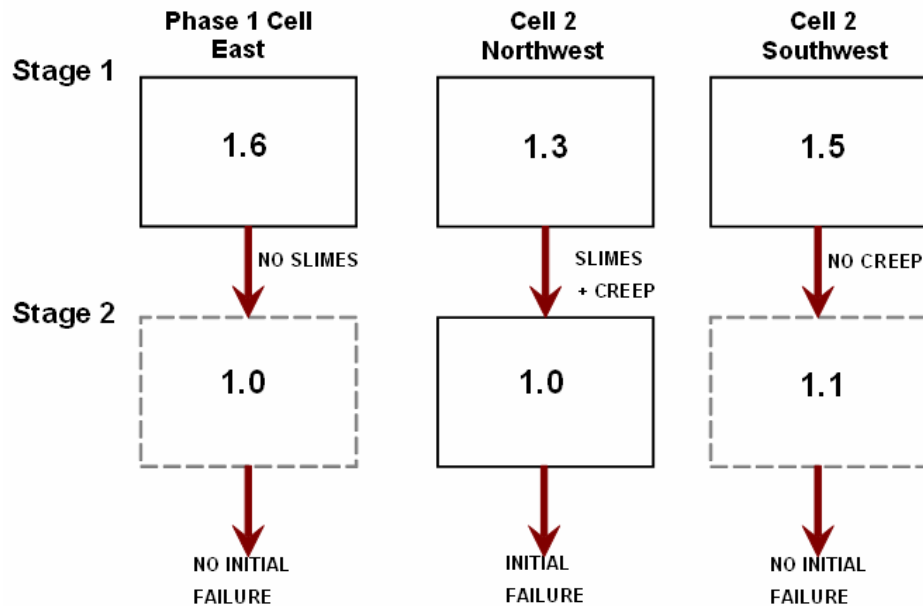
Figure 1.6.3\_21 Comparison of Undrained Ash Computed Stability at Critical Sections Using SLOPE/W

It is evident to AECOM, from the known sequence of events and relic movements that the failure initiated at or very close to the Northwest Cell 2 section. Therefore, the Northwest Cell 2 section became unstable before the east side of the Phase I Emergency Dredge Cell and the Southwest Cell 2 sections were impacted. Even though ash was lost from behind the east side of the Phase I Emergency Dredge Cell and failure took place at the Southwest Cell 2 section, the order of events implies that failure at these locations was a consequence, or domino effect, caused by the failure at the Northwest Cell 2 section.

Figure 1.6.3\_21 below shows the computed FS against slope stability using SLOPE/W for the three sections discussed above. In this chart, a two stage analysis was performed. Stage 1 is defined by the condition where no excess water pressures are developed in the fly ash. Therefore, the fly ash is modelled in AECOM's analysis using drained strength parameters, representing a long term and stable condition. Stage 2 is modelled assuming that the sluiced ash develops positive excess pore water pressures due to its contractive behaviour. Therefore, the fly ash is modelled in Stage 2 using undrained strength parameters.
